**Spencer Historic Preservation Commission  
Regular Meeting Agenda  
Monday, May 20, 2024, 7:00 P.M.**

**New Business:**

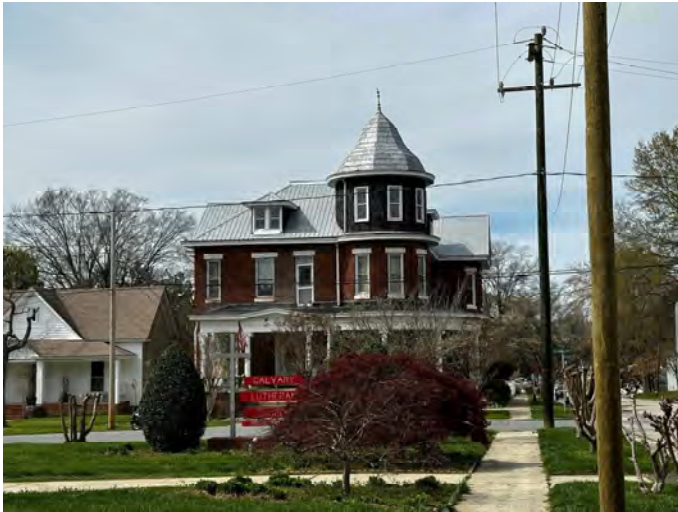
Figure 1 Roof Detail (New Standing Seam Metal Panels). Site Visit 3-25-2024 by Kyle Harris, HPC Liaison.

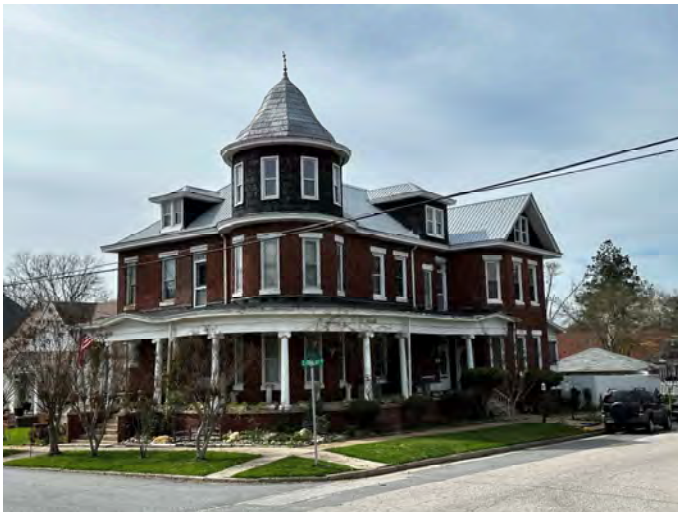
Figure 3 Roof Detail (New Standing Seam Metal Panels). Site Visit 3-25-2024 by Kyle Harris, HPC Liaison.

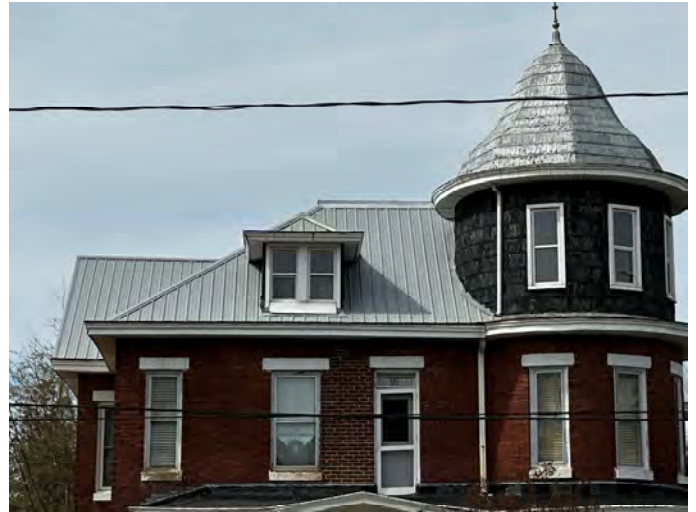
Figure 2 Roof Detail (New Standing Seam Metal Panels). Site Visit 3-25-2024 by Kyle Harris, HPC Liaison.

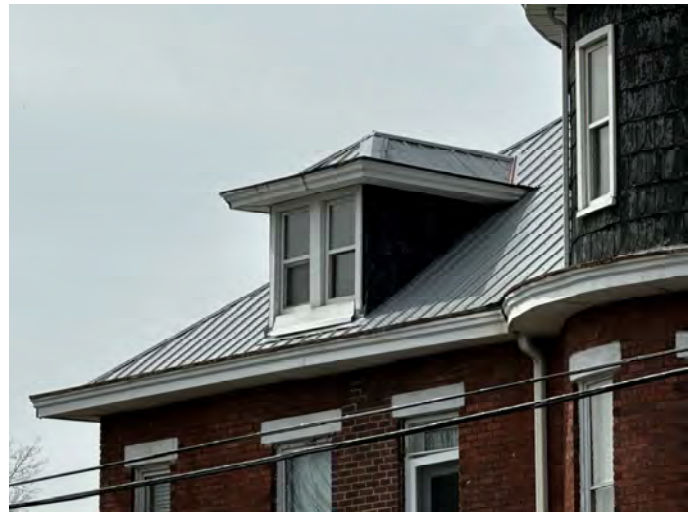
Figure 4 Roof Detail (New Standing Seam Metal Panels). Site Visit 3-25-2024 by Kyle Harris, HPC Liaison.

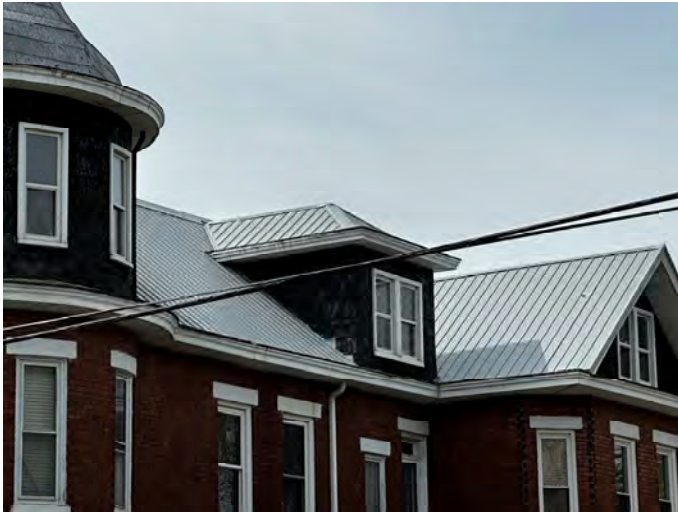
Figure 5 Roof Detail (New Standing Seam Metal Panels). Site Visit 3-25-2024 by Kyle Harris, HPC Liaison.

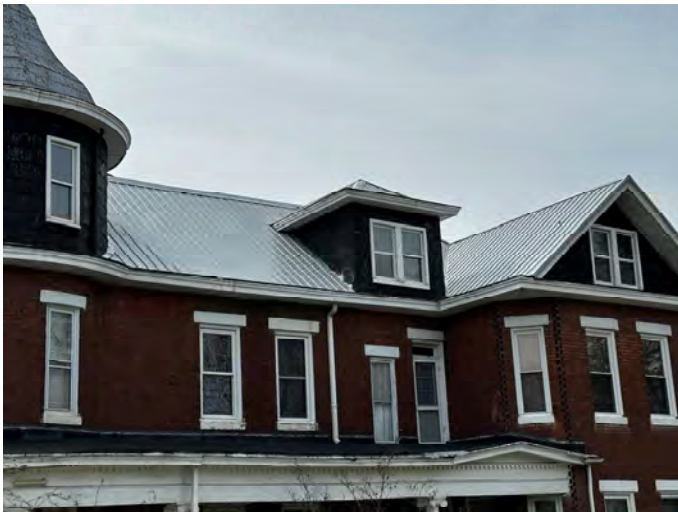
Figure 7 Roof Detail (New Standing Seam Metal Panels). Site Visit 3-25-2024 by Kyle Harris, HPC Liaison.

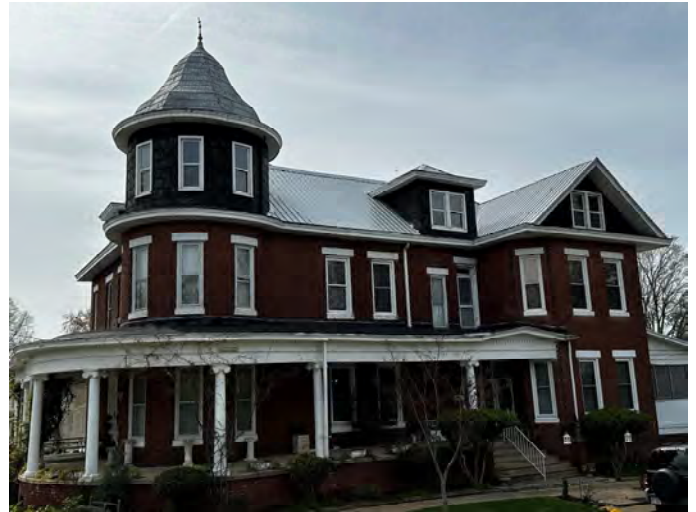
Figure 6 Roof Detail (New Standing Seam Metal Panels). Site Visit 3-25-2024 by Kyle Harris, HPC Liaison.

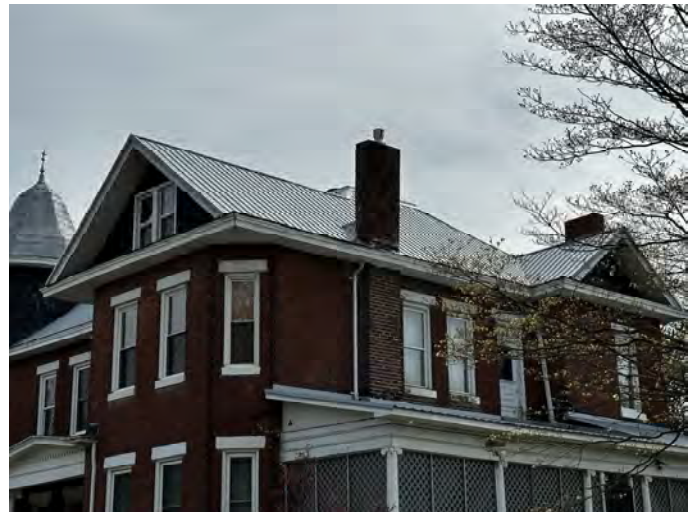
Figure 8 Roof Detail (New Standing Seam Metal Panels). Site Visit 3-25-2024 by Kyle Harris, HPC Liaison.

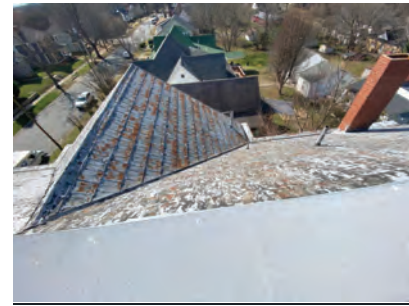
**DESECRATED ROOF TILES NO 1.**

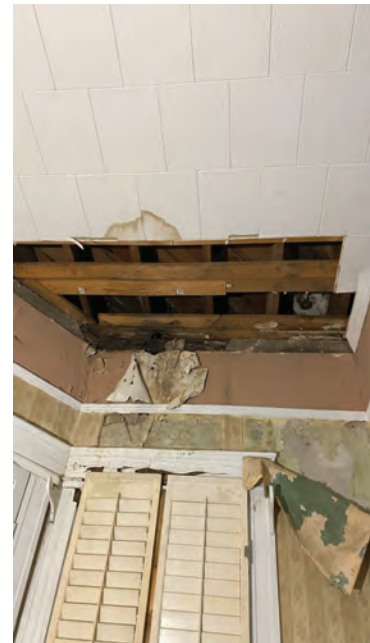
EXISTING WATER DAMAGED DINING ROOM WALL AND CEILING ON FIREPLACE WALL TOWARDS REAR OF HOUSE NO 1

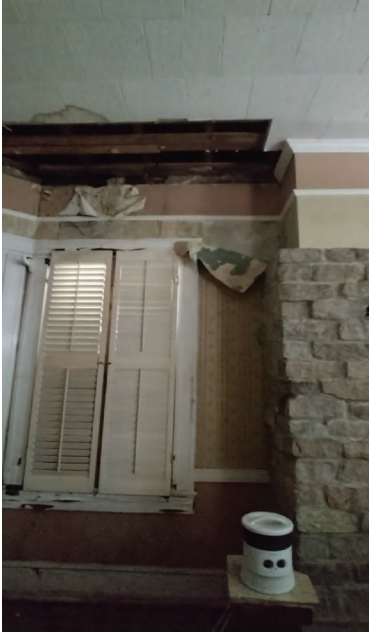
EXISTING WATER DAMAGED DINING ROOM WALL AND CEILING ON FIREPLACE WALL TOWARDS REAR OF HOUSE NO 2

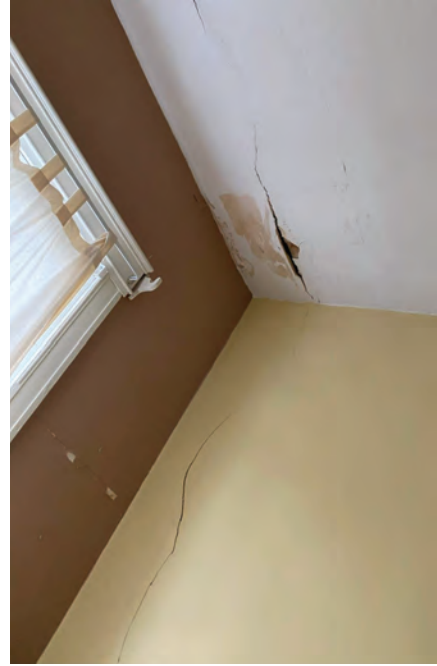
EXISTING WATER DAMAGED SECOND FLOOR WALLS AND CEILING. ROOM AT REAR OF HOUSE NO 3

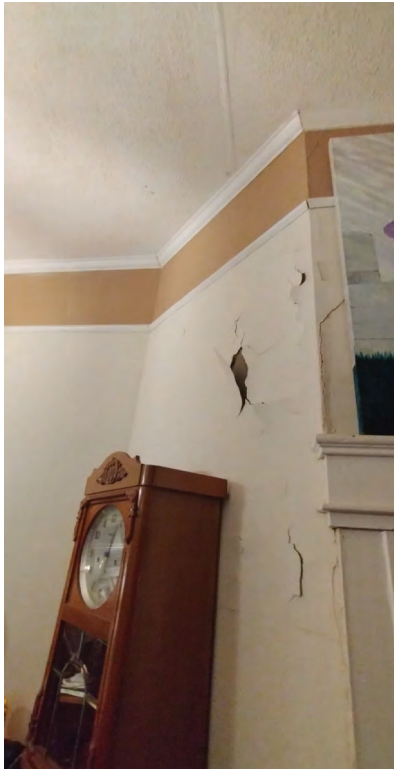
EXISTING WATER DAMAGED WALL AND CEILING IN MAIN HALL ON FIRST FLOOR NO 4  
Page 10

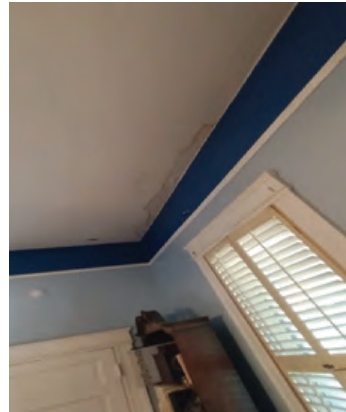
EXISTING WATER DAMAGED BEDROOM CEILING ON FIRST FLOOR 5<sup>TH</sup> ST SIDE OF HOUSE NO 5

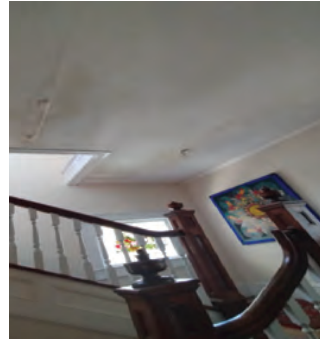
EXISTING WATER DAMAGED ENTRY ROOM CEILING AT FRONT OF HOUSE NO 6  
Page 11

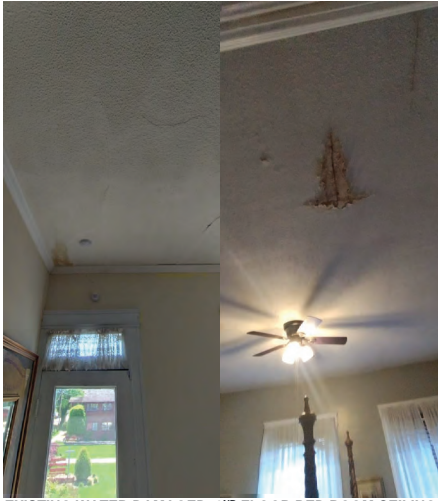
EXISTING WATER DAMAGED 2<sup>ND</sup> FLOOR BED ROOM CEILING  
1ST FLOOR 5<sup>TH</sup> ST SIDE WALL AND NO 7

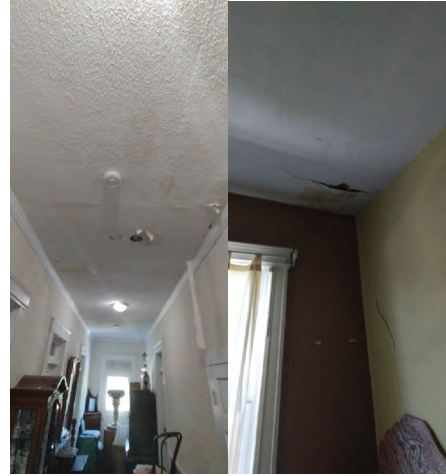
EXISTING WATER DAMAGED 2<sup>ND</sup> FLR WALL & CEILING REAR  
2<sup>ND</sup> FLOOR CEILING NO 8

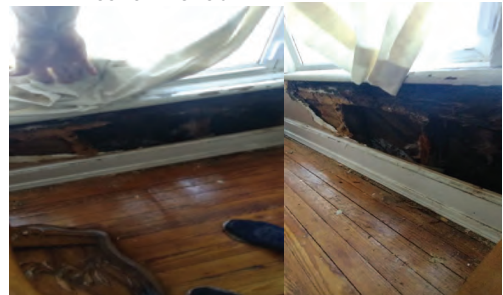
EXISTING WATER DAMAGED 2<sup>ND</sup> FLR REAR BED ROOM NO 9  
Page 13

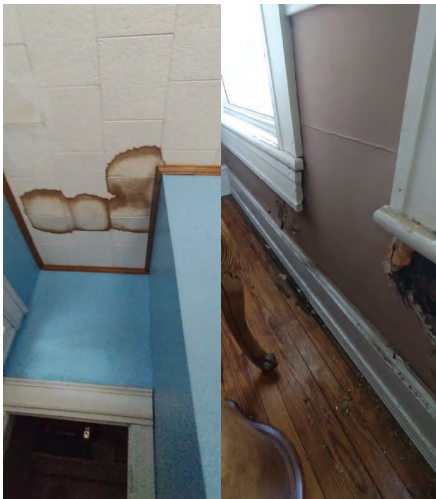
EXISTING WATER DAMAGED BEDROOM WALL CEILING AND  
FLOOR TOWARDS REAR OF BLDG. ABOVE DINING ROOM NO 10  
Page 14

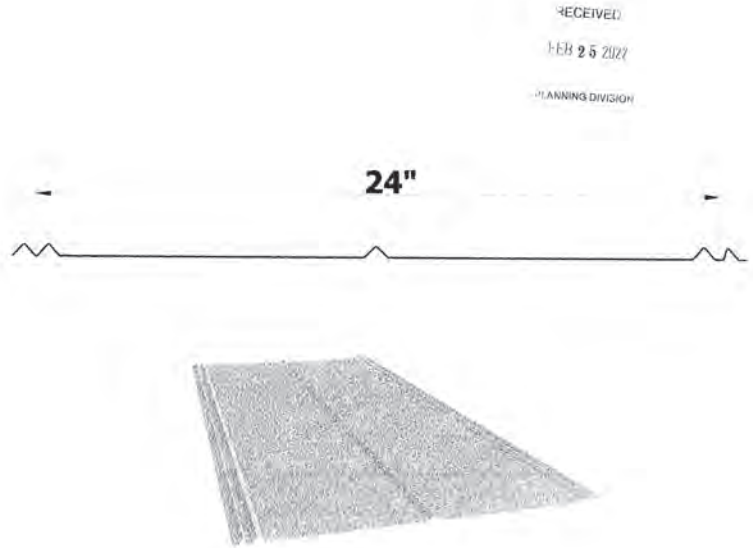
Exhibit 5-E: Applicant-Submitted Evidence & Doc  
 5-E-4: Supporting Documents from Wilmington NC 05-15-24 **ATTACHMENT 4**

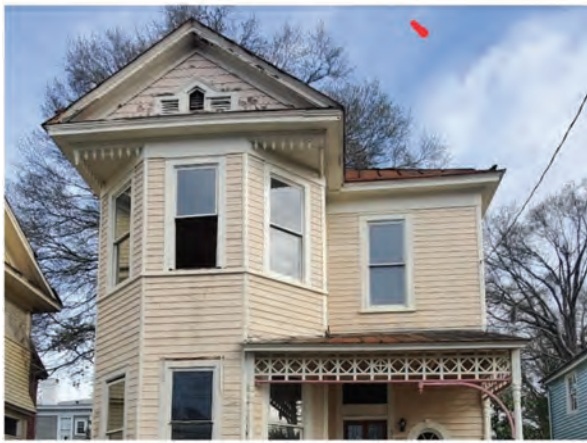
ATTACHMENT 6 Page 1  
Submitted Evidence & Documentation  
ments from Wilmington NC 05-15-24

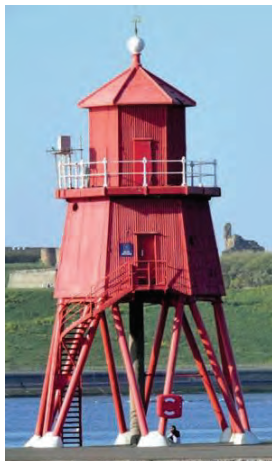
Herd Groyne Lighthouse (1881), South Shields, Tyne and Wear (Photo: Emma Joyce)

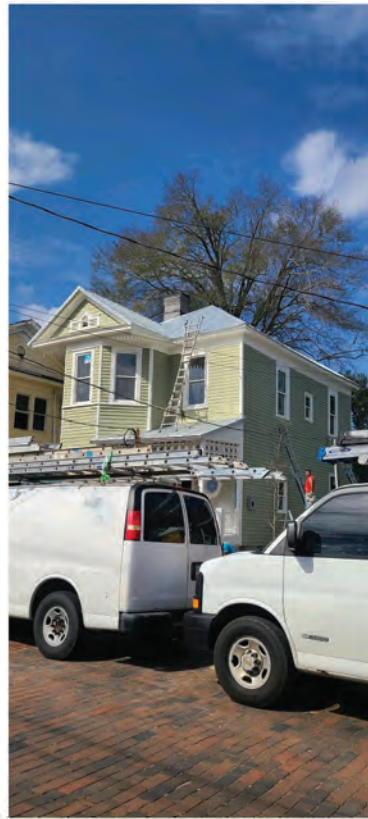
ATTACHMENT 6 Page 2  
Submitted Evidence & Documentation  
ments from Wilmington NC 05-15-24

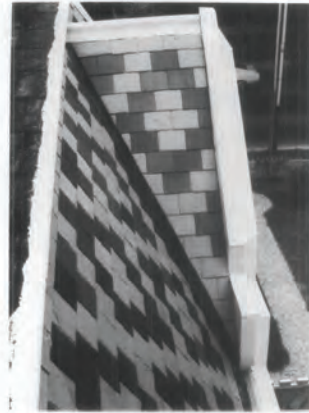
The Victorians loved to use different colored slates to create decorative patterns on their roofs, an effect which cannot be easily duplicated by substitute materials. Before any repair work on a roof such as this, the slate sizes, colors, and position of the patterning should be carefully recorded to assure proper replacement. (Ebenzer Maxwell Mansion, Philadelphia, Pennsylvania, photo courtesy of William D. Hershhey)

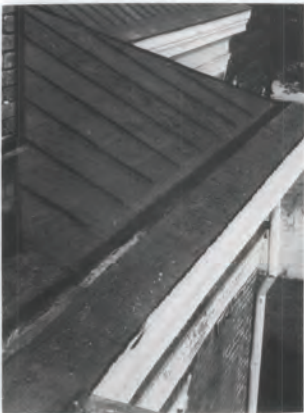
Repeated repair with asphalt, which cracks as it hardens, has created a blistered surface on this sheet-metal roof and built-in gutter, which will retain water. Repairs could be made by carefully heating and scraping the surface clean, repairing the holes in the metal with a flexible mastic compound or a metal patch, and coating the surface with a fiber paint. (Houma County Courthouse, Kingston, Tennessee, photo courtesy of Building Conservation Technology, Inc.)

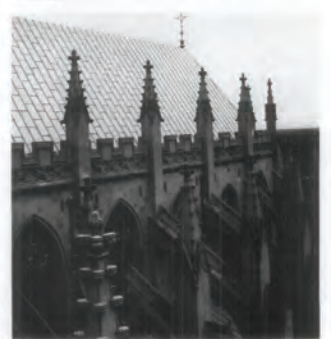
Good design and quality materials for the roof surface, fastenings, and flashing minimize roofing failures. This is essential on roofs such as on the National Cathedral where a thorough maintenance inspection and minor repairs cannot be done easily without special scaffolding. However, the success of the roof on any structure depends on frequent cleaning and repair of the gutter system. (Washington, D.C., photo courtesy of John Burns, A. I. A.)

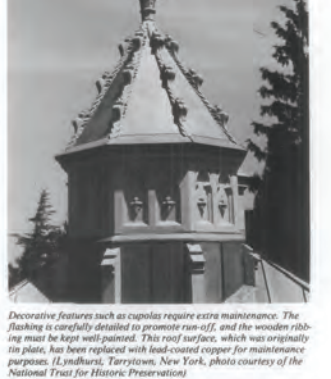
Decorative features such as cupolas require extra maintenance. The flashing is carefully detailed to promote run-off, and the wooden ribbing must be kept well-painted. This roof surface, which was originally tin plates, has been replaced with lead-coated copper for maintenance purposes. (Lynchburg, Tarrytown, New York, photo courtesy of the National Trust for Historic Preservation)

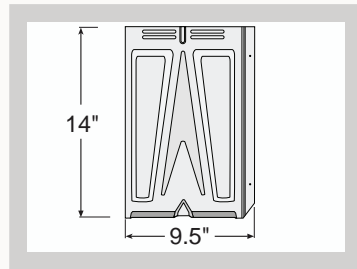
**Steel:** A heart of high-tensile steel guarantees strength and endurance, ensuring Victorian shingles are ready to weather anything nature throws its way.

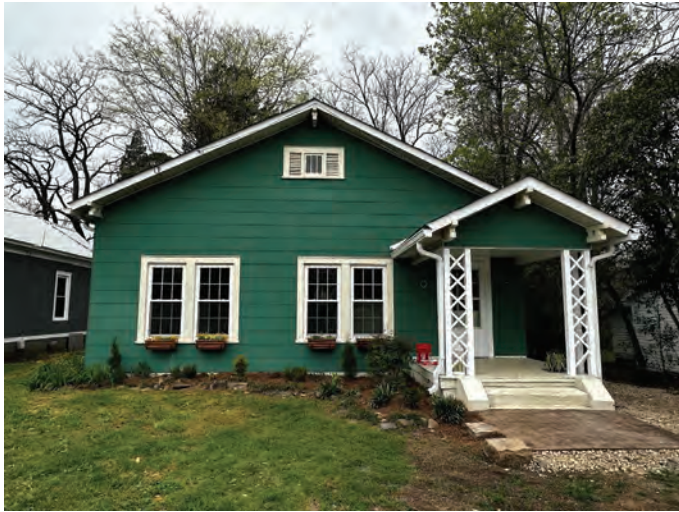
Figure 1 Window Detail (New Vinyl Replacement Windows). Site Visit 3-26-2024 by Kyle Harris, HPC Staff Liaison.

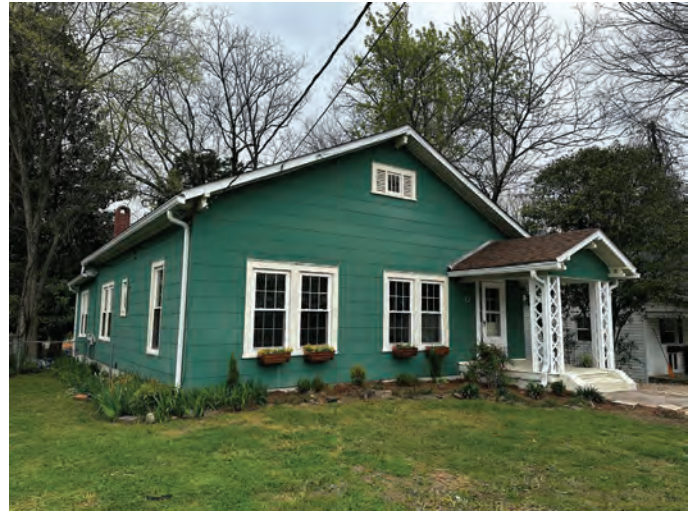
Figure 2 Window Detail (New Vinyl Replacement Windows). Site Visit 3-26-2024 by Kyle Harris, HPC Staff Liaison.

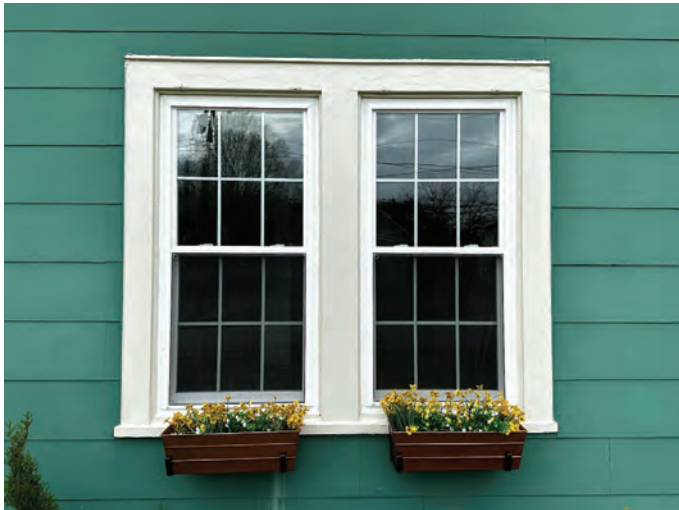
Figure 3 Window Detail (New Vinyl Replacement Windows). Site Visit 3-26-2024 by Kyle Harris, HPC Staff Liaison.

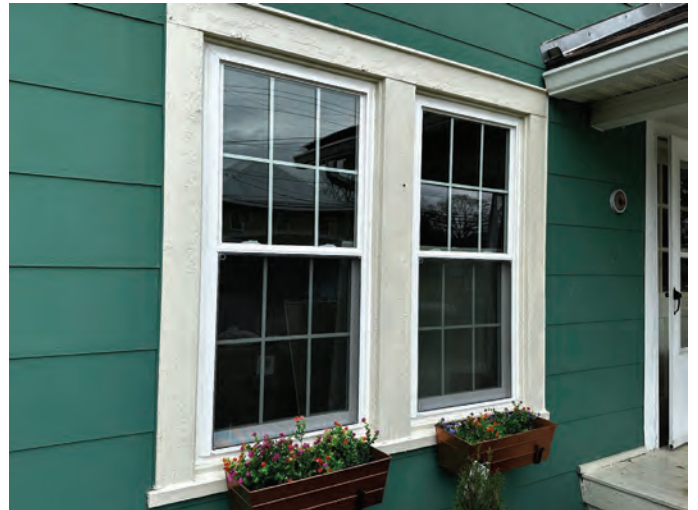
Figure 4 Window Detail (New Vinyl Replacement Windows). Site Visit 3-26-2024 by Kyle Harris, HPC Staff Liaison.

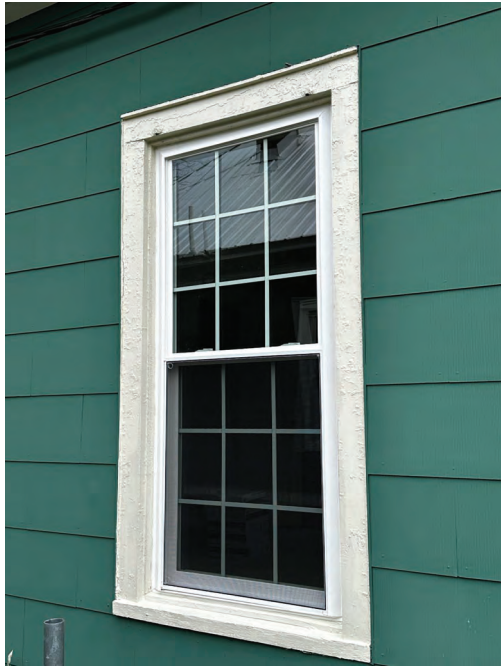
Figure 5 Window Detail (New Vinyl Replacement Windows). Site Visit 3-26-2024 by Kyle Harris, HPC Staff Liaison.

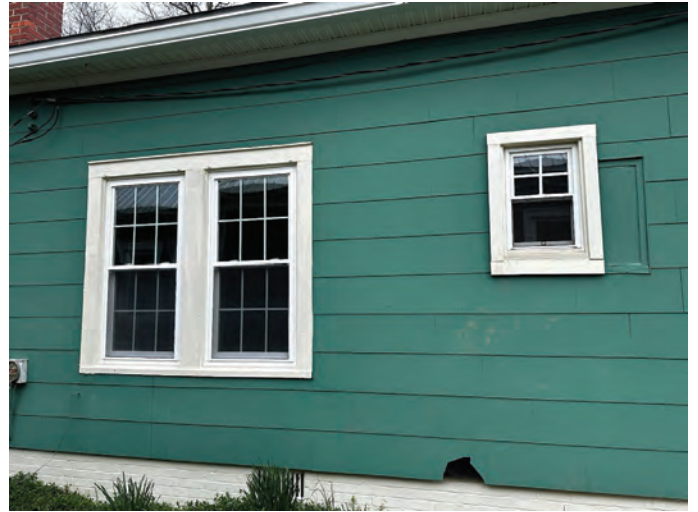
Figure 6 Window Detail (New Vinyl Replacement Windows). Site Visit 3-26-2024 by Kyle Harris, HPC Staff Liaison.

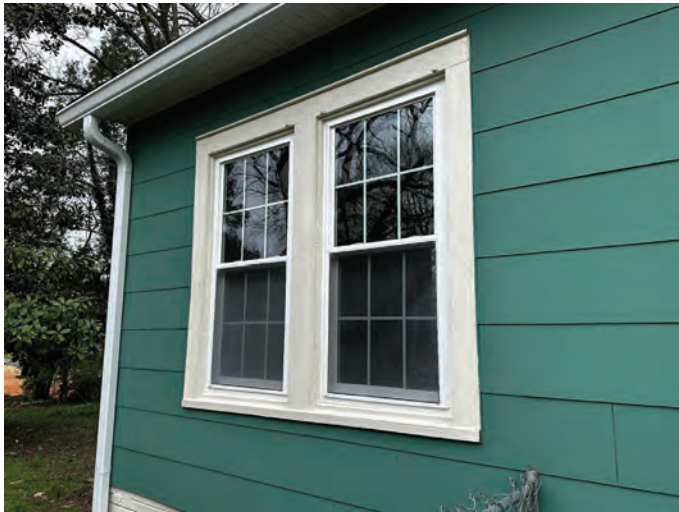
Figure 7 Window Detail (New Vinyl Replacement Windows). Site Visit 3-26-2024 by Kyle Harris, HPC Staff Liaison.

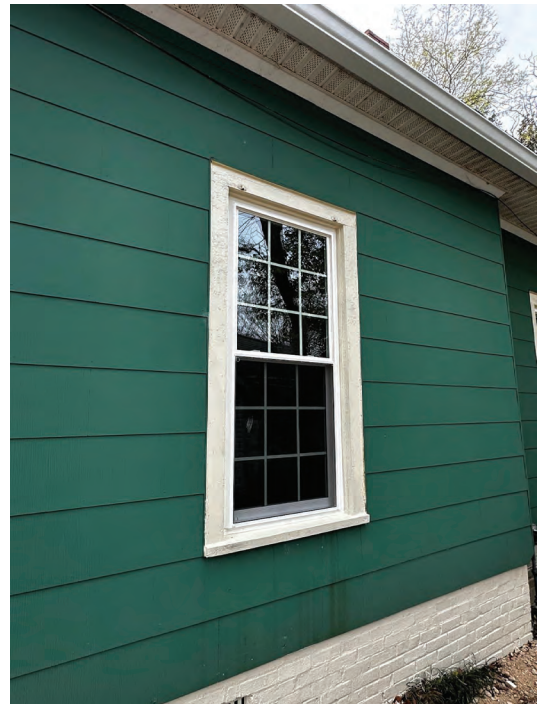
Figure 8 Window Detail (New Vinyl Replacement Windows). Site Visit 3-26-2024 by Kyle Harris, HPC Staff Liaison.

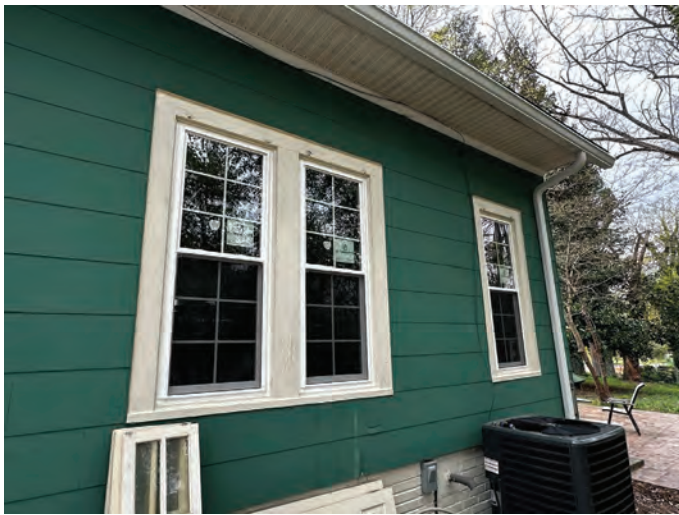
Figure 9 Window Detail (New Vinyl Replacement Windows). Site Visit 3-26-2024 by Kyle Harris, HPC Staff Liaison.

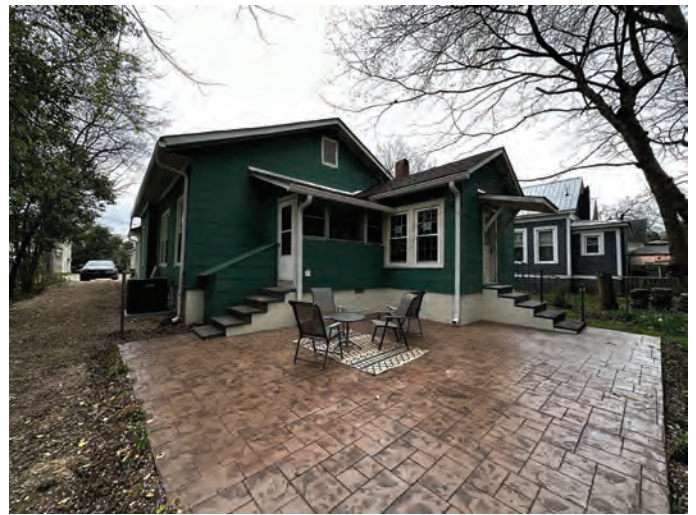
Figure 10 Window Detail (New Vinyl Replacement Windows). Site Visit 3-26-2024 by Kyle Harris, HPC Staff Liaison.

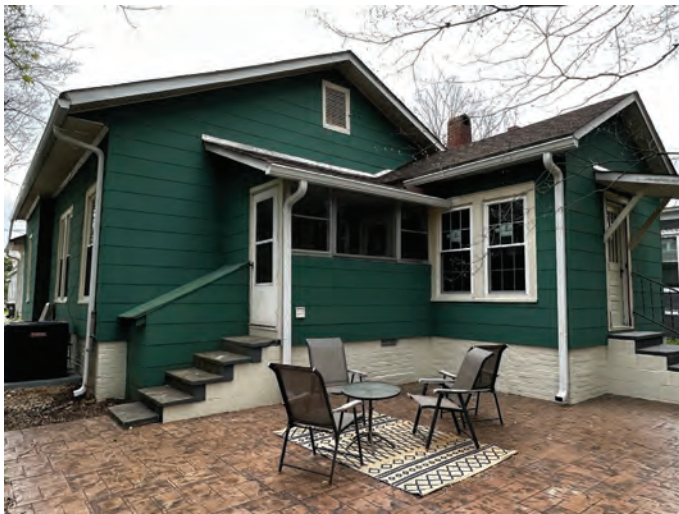
Figure 11 Window Detail (New Vinyl Replacement Windows). Site Visit 3-26-2024 by Kyle Harris, HPC Staff Liaison.

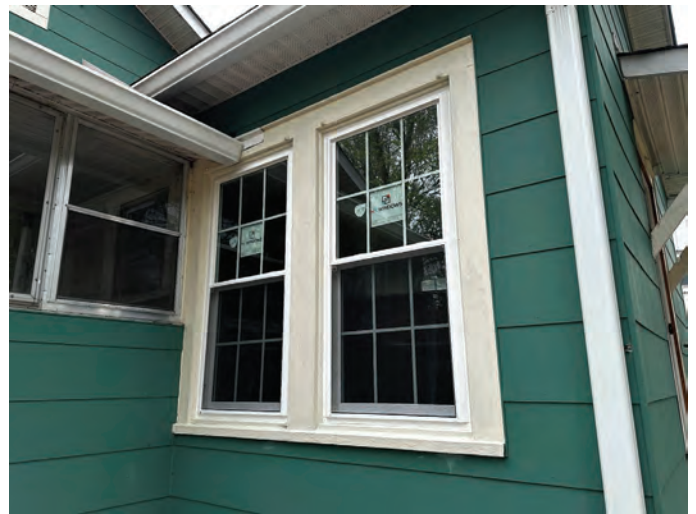
Figure 12 Window Detail (New Vinyl Replacement Windows). Site Visit 3-26-2024 by Kyle Harris, HPC Staff Liaison.

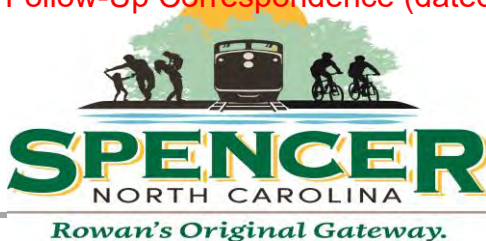
For your window replacement proposal, a manufacturer's brochure or specifications for the replacement windows are requested.

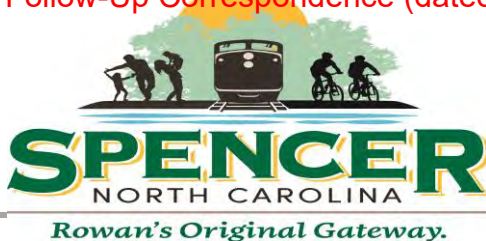
**When preparing evidence to demonstrate that your proposal meets the above standards, I would advise you to consider submitting the following evidence:**

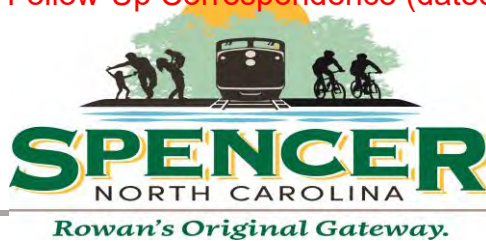
Post Office Box 45  
Spencer, NC 28159-0045
